Climate Change and Buildings

Developing a building assessment triage tool

Mark Porter PEng., StructEng., FIStructE

November 2013

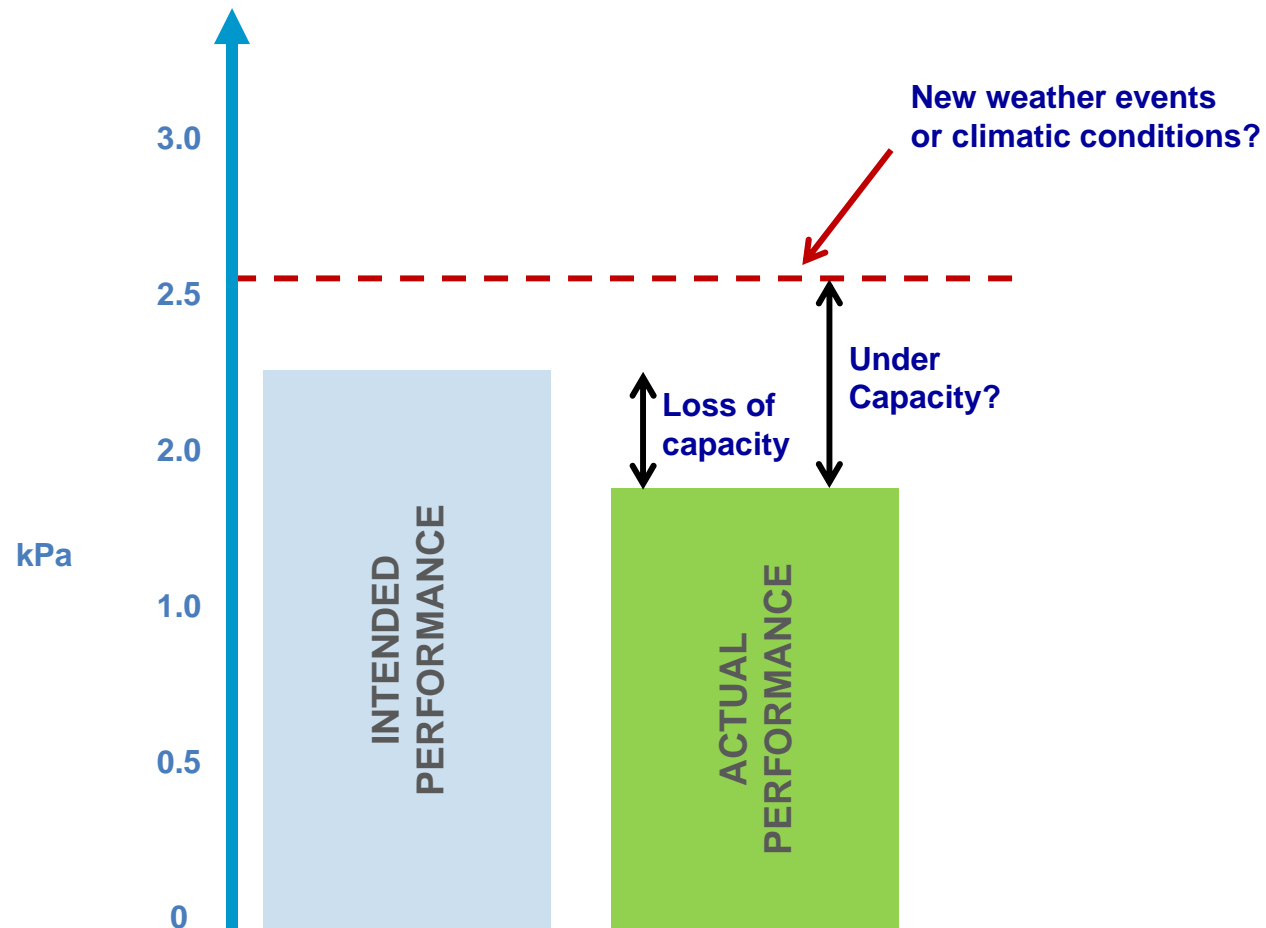
What do we mean by 'Capacity'

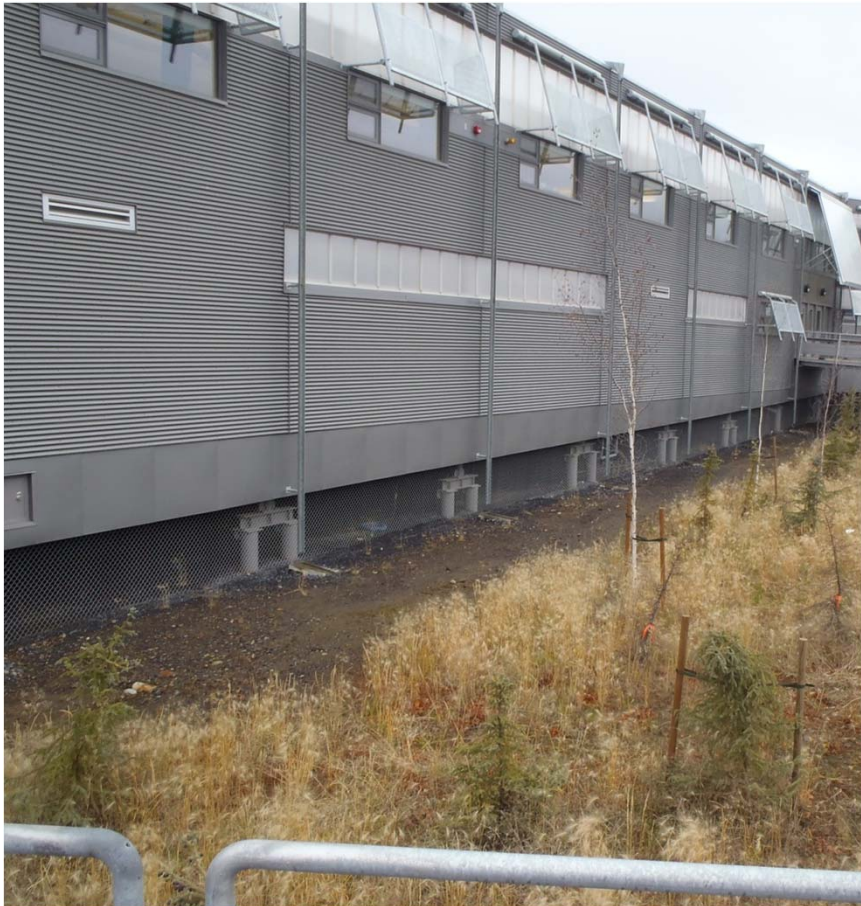
What does the tool focus on?

Permafrost related parameters:

1. Sloping of the ground around the building
2. Control of roof drainage
3. Use of the land immediately surrounding the building
4. Presence of open air space between the building and the ground
